Test Report - Temporary Underslung Handrail

30B-15-0096-TRP-391792-0

Vipac Engineers & Scientists (Vipac) has been commissioned by Aldeck Sales Pty Ltd (the client) to undertake performance testing on their temporary underslung perimeter handrail system.

Testing was carried out in accordance with Section 4.1 of AS/NZS 4994.1:2009 *Temporary edge protection Part 1: General requirements*. Testing was carried out at the client's Thomastown facility during December 2015.

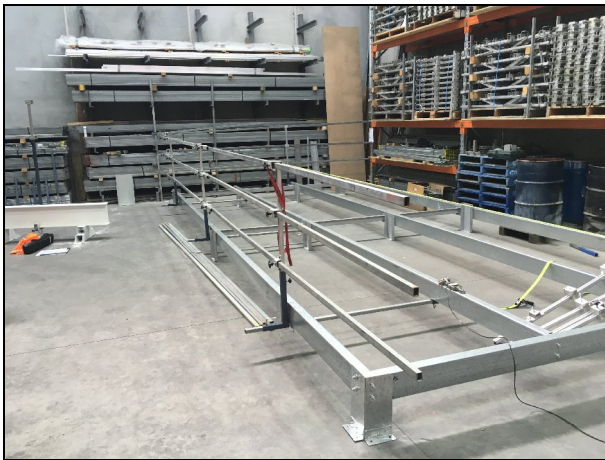
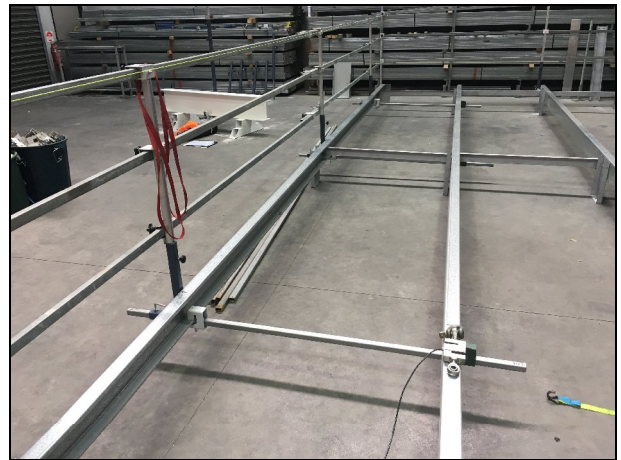
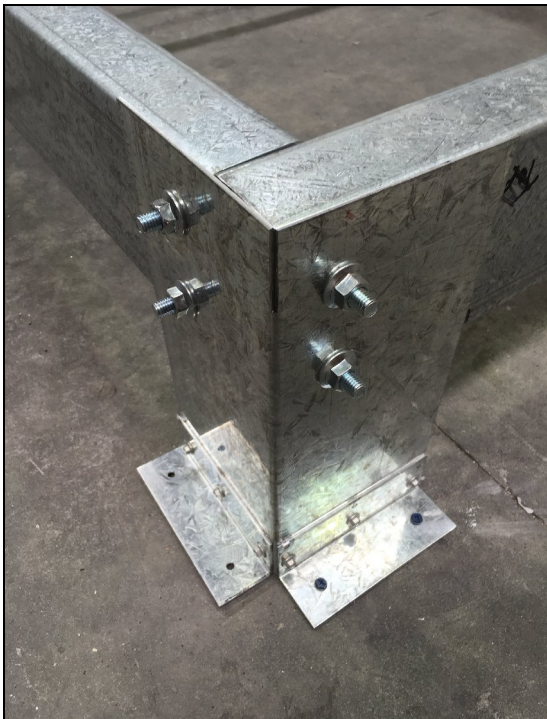
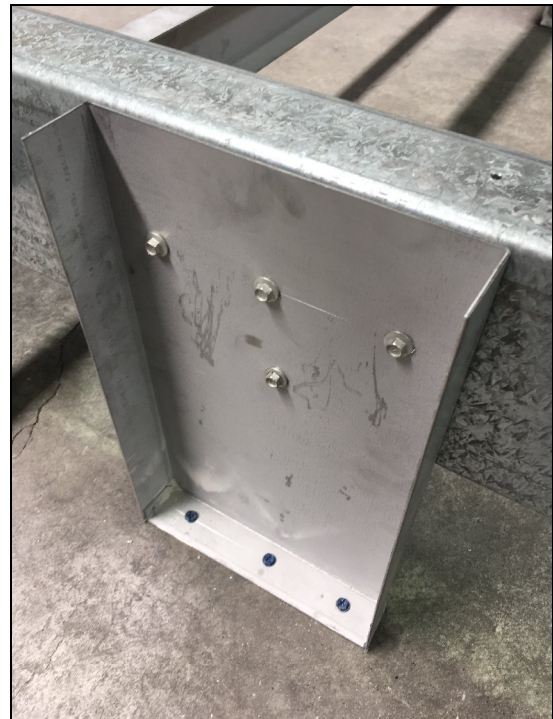
The system was installed on a custom test rig built by the client at their Thomastown facility. The client has advised that materials of the same characteristics as the intended supporting structure were used to build the test rig as to simulate the manner of installation. Figure 5 to Figure 8 shows the test rig. The system was tested in accordance with the test specification outlined in Section 3. During testing, the static load was applied to the system using a lifting and ratchet straps. The load cell was installed inline with these straps to ensure the correct load was applied. Figure 9 illustrates the static load application setup. Deflection of the post was measured at the position of the top rail and the deflection of the rails was measured at the top surface of the rail.

Figure 5: Test rig

Figure 6: System installed on test rig

Figure 7: Corner support of test rig

Figure 8: Mid support of test rig

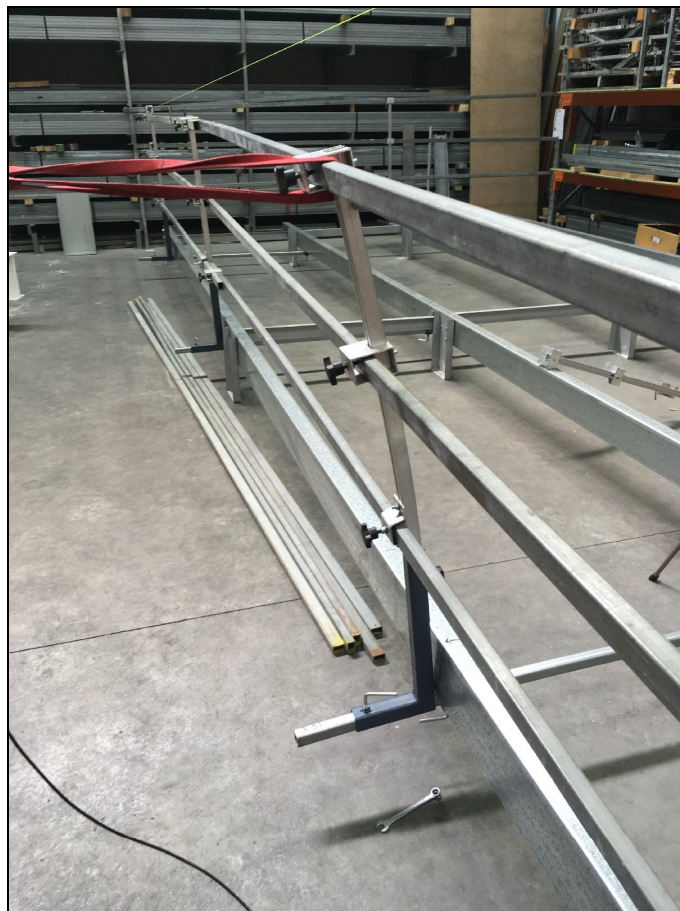
Applied Load: Proof = 627.8 N, Maximum = 1226.3 N

Net Deflection: 87 mm

Result: Pass – deflection less than 101 mm, no ultimate failure

Figure 10: Post with 380 mm steel base under maximum static load

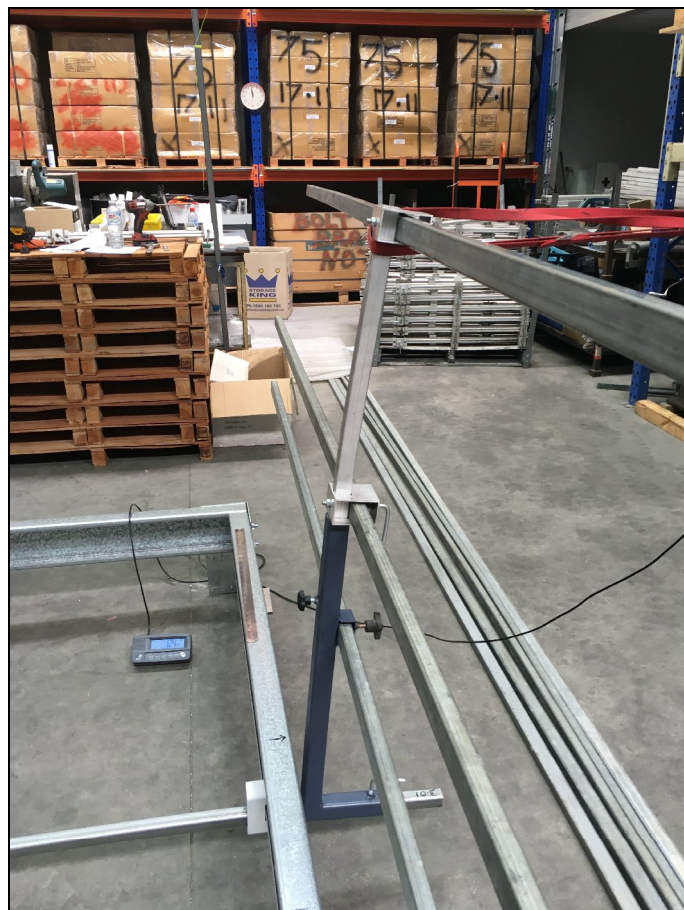
Applied Load: Proof = 608.2 N, Maximum = 1216.4 N

Net Deflection: 71 mm

Result: Pass – deflection less than 101 mm, no ultimate failure

Figure 11: Post with 660 mm steel base under maximum static load
